DEPARTMENT OF ECOLOGY  
INSPECTION REPORT

To: D. Cargill  
Inspectors: M. Turvey, J. Polayes-Wien  
Date of Visit: November 17, 1992  
Date of Inspection Report: December 15, 1992  
Permit No.: WA- N/A New Industry: ☐ Yes ☒ No  
Permit Expires: N/A

Facility: Ace Galvanizing, Inc.  
Address : 429 South 96th Street  
City: Seattle ZIP: 98108 County: King  
Telephone: (206) 762-0330  
Person Contacted: Mike Buckland  
Type of Facility: Hot dip galvanizing, pickling and oiling  
Receiving Water: Duwamish Waterway  
Type of Treatment System: BMP's, Recirculation

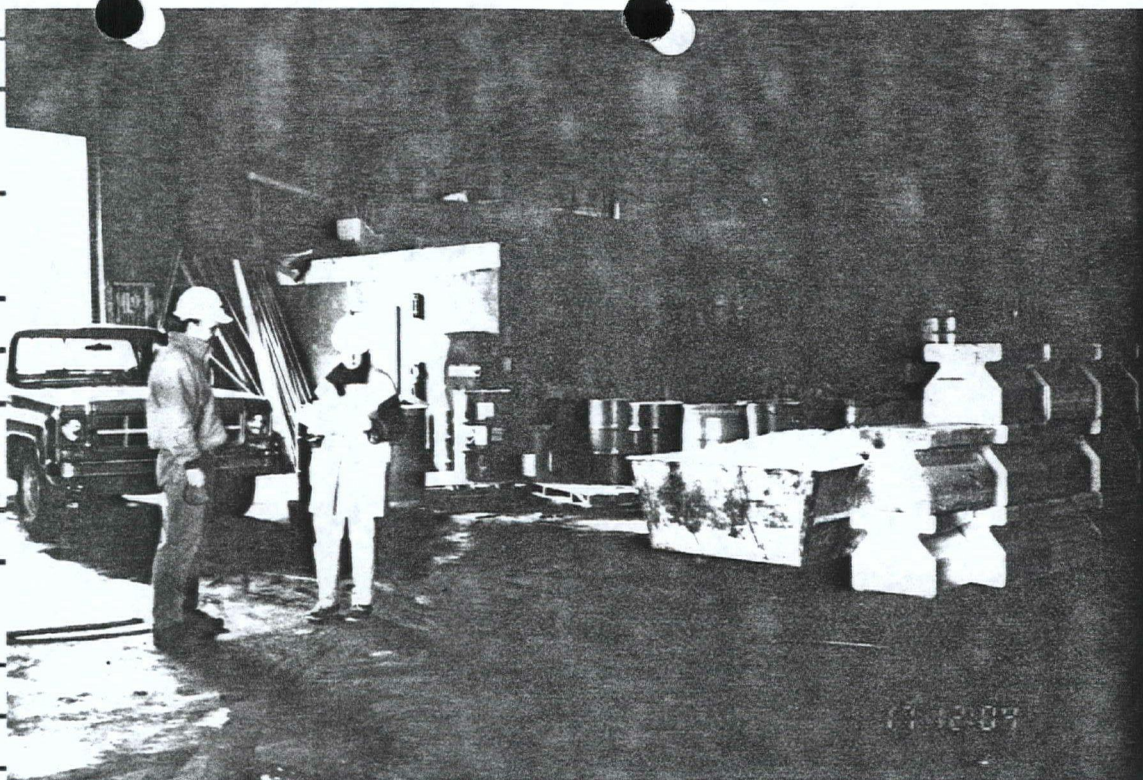
PHOTO NO.: 1

**NARRATIVE:** We arrived at the facility at 10:50 and met with Mike Buckland, General Manager who agreed to show us the facility. We began with looking at the facility's warehouse. The warehouse is used for storage of drums containing muriatic acid, zinc skimmings, iron salts, and zinc ammonium along with bags of chloride crystal. There were no floor drains in the warehouse and the drums and bags of crystal were stored neatly.

Interior of  
warehouse used  
for storage of  
supplies, chemicals.  
No drains in  
building

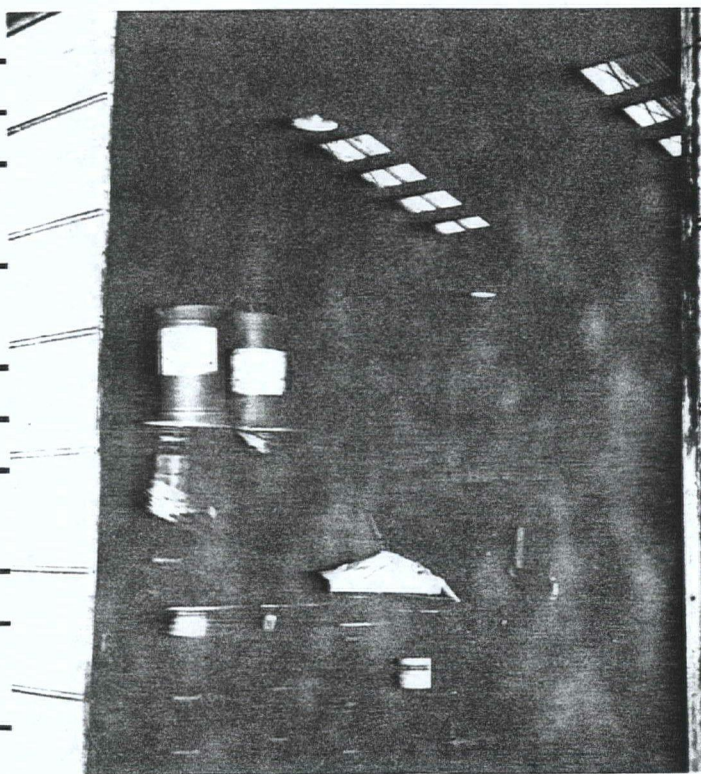
PHOTO NO.: 2

Same building  
as photo #1  
Drums stored  
inside warehouse

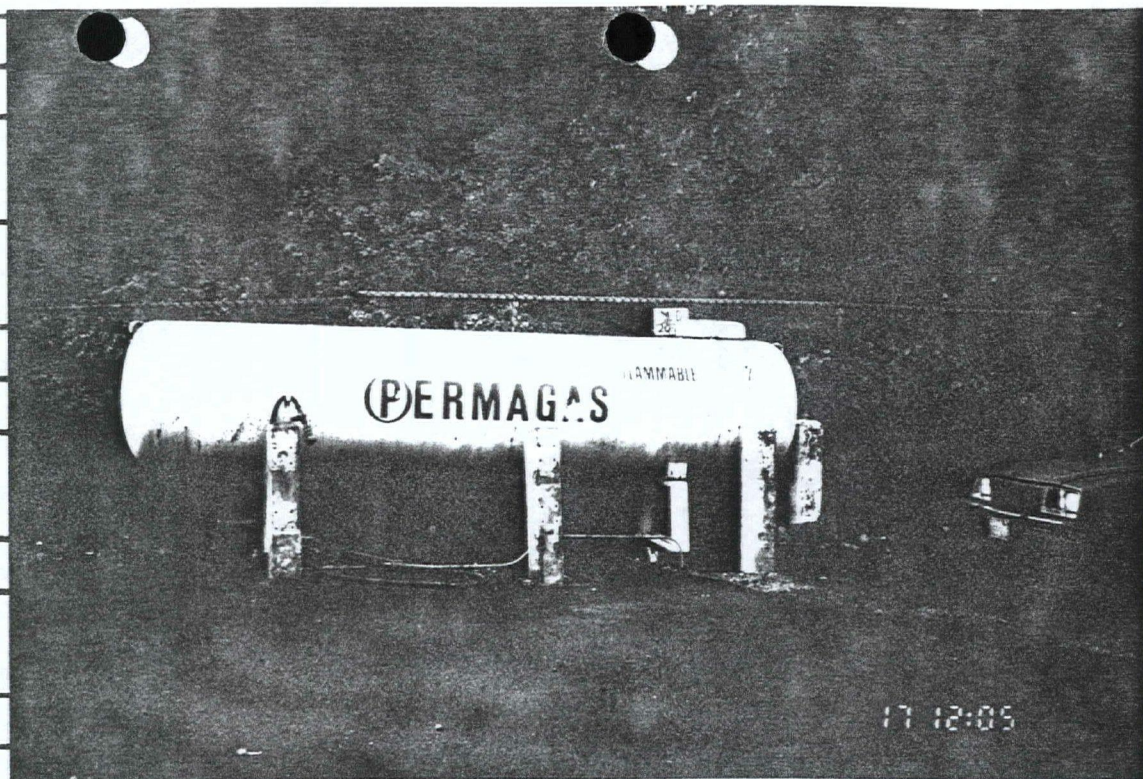
PHOTO NO.: 3

Propane tank  
stored outside

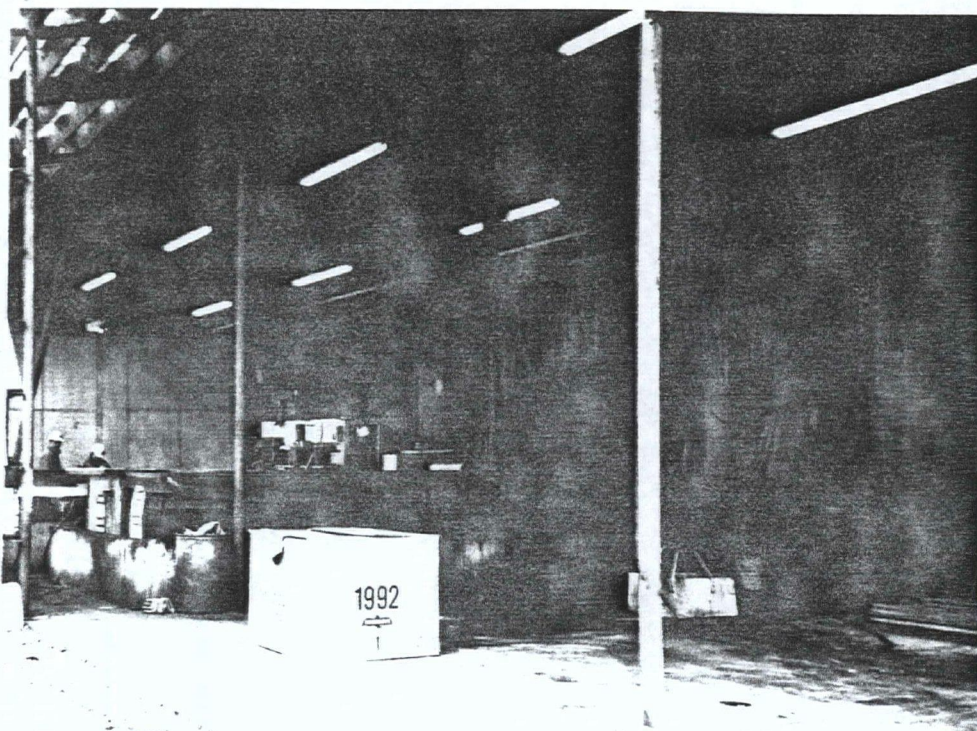
PHOTO NO.: 4

In addition, Ace Galvanizing operates a pickling and oiling operation for piping (see photos #4,6,7). This process includes surface preparation which includes degreasing piping, followed by a caustic rinse, hydrochloric acid pickling, hydrochloric acid rinse, neutralization with sodium metasilicate, and oiling.

Tanks contain  
hydrochloric acid,  
acid rinse,  
inhibitor, & hydraulic oil. On side of  
warehouse, under cover.

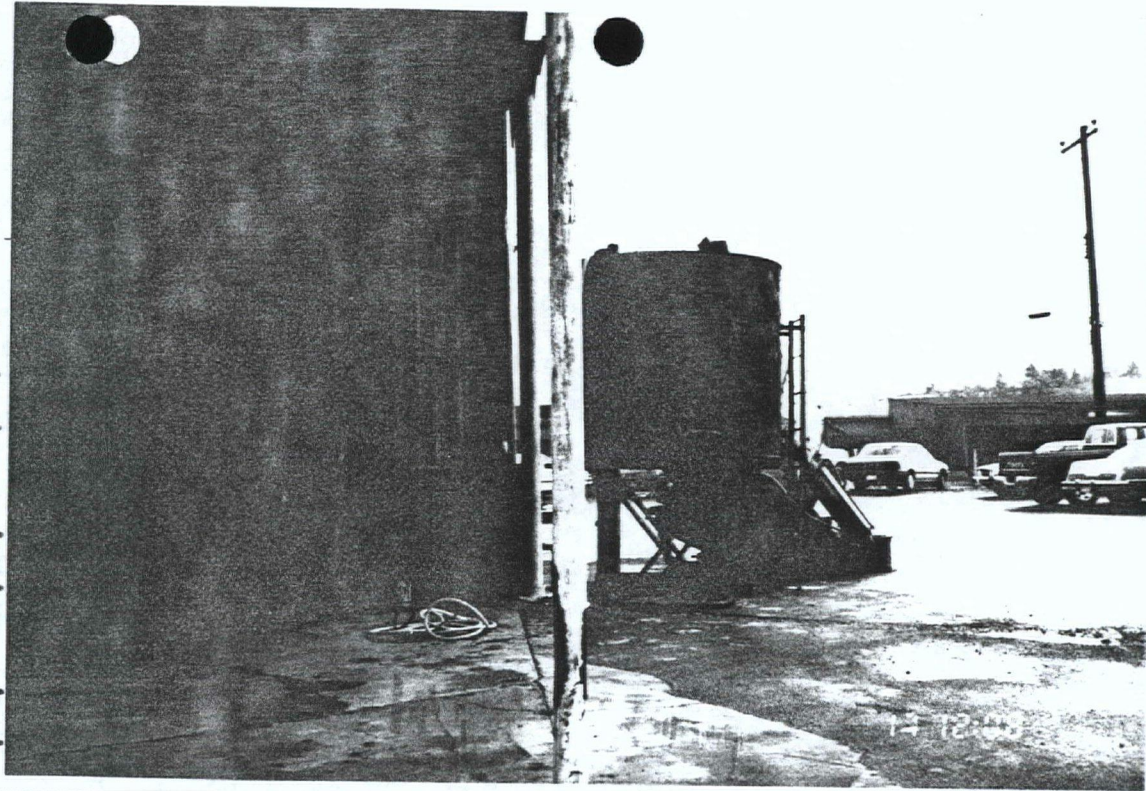
PHOTO NO.: 5

The pickling and oiling operation is located next to the warehouse. It consists of a series of tanks and finally a bermed area where pipes are set up to drip dry and are prepared for shipment. Mr. Buckland said that the oil in this pickling process is only changed about once every two years. The tanks are protected by a roof and partial side walls. The tanks rest on a concrete surface. There were no drains in this area. Also next to the warehouse is a 8-900 gallon tank resting on a metal pallet without secondary containment or cover (see photo #5). The tank is used to store waste oil. Mr. Buckland said that it is not full and it takes a long time to accumulate oil.

Tanks used to  
store waste oil.

No secondary  
containment or cover

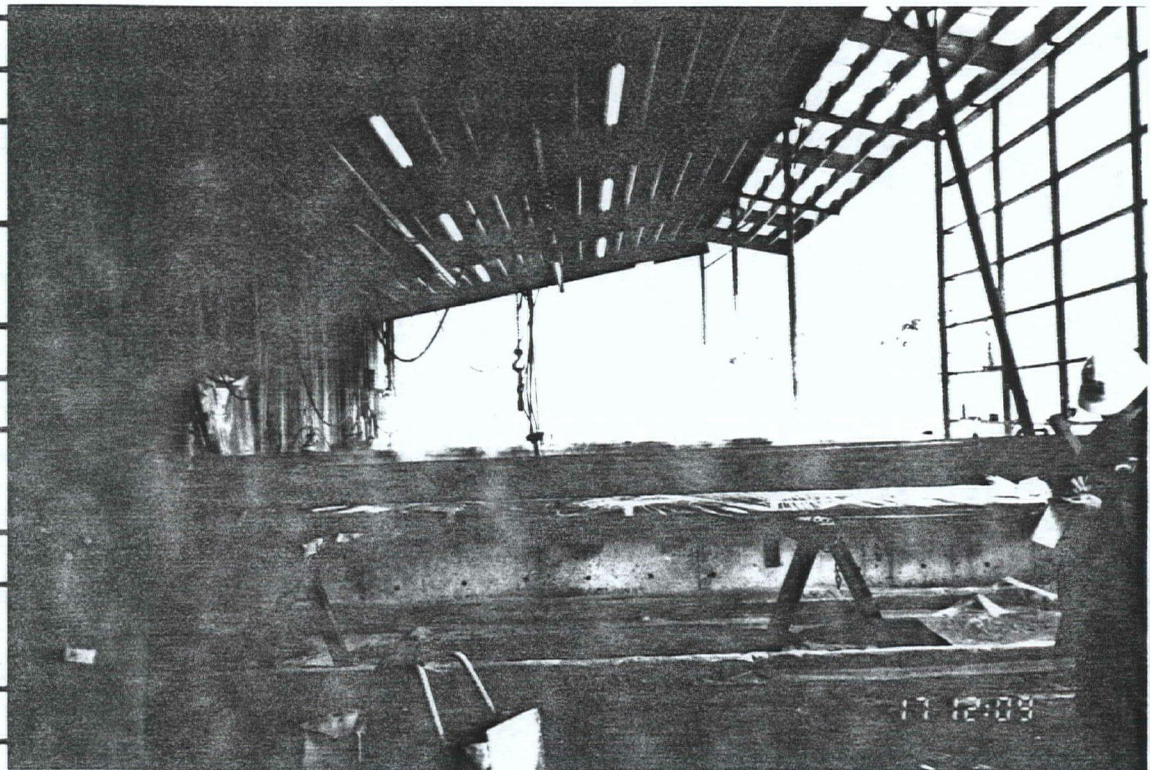
PHOTO NO.: 6

Tanks on side of  
warehouse. Pipes  
at end of process

are wrapped in plastic. Stored on pallets within bermed enclosure  
to capture any oil that may drip from pipes. Enclosure is  
lined with plastic to make it easier to collect oil.

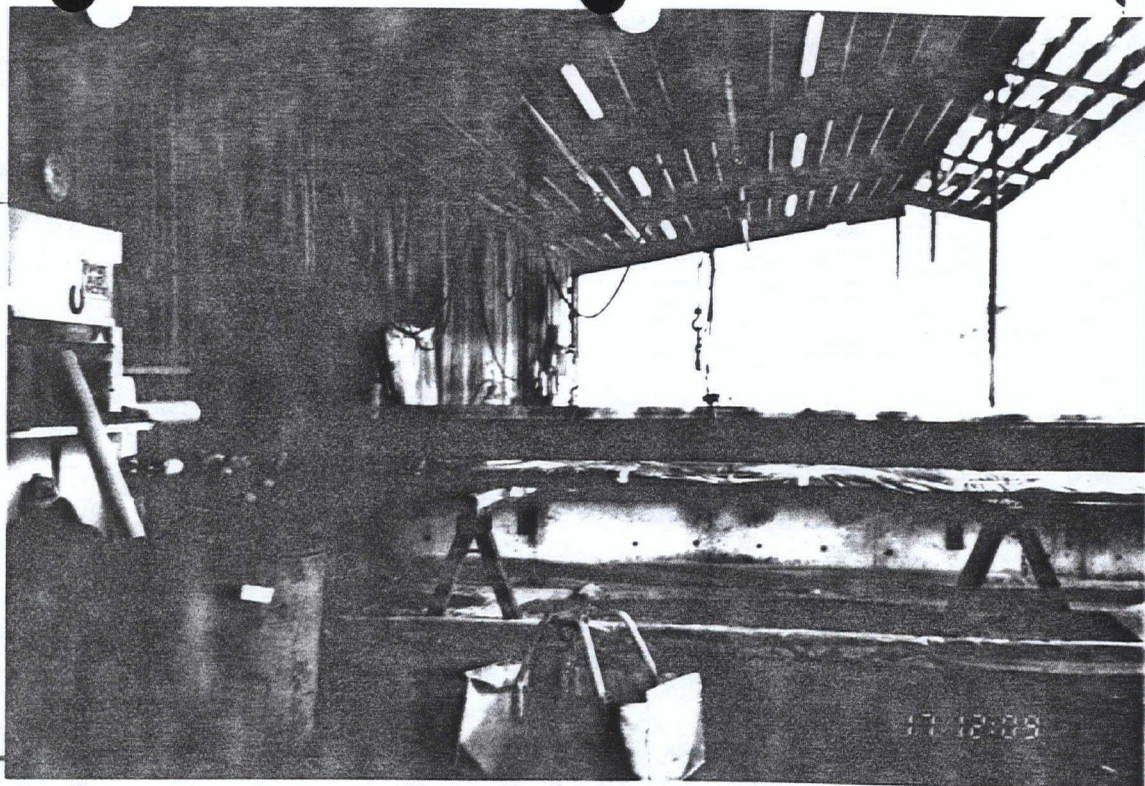
PHOTO NO.: 7  
DATE: 11/17/92  
TIME: 12:09  
TAKEN BY:  
J. Polaygs-Wier  
WITNESS:  
M. Turvey  
FILM: KODAK 200  
CAMERA: 35 mm  
LOCATION:  
Ace Galvanizing  
Seattle, WA.  
DESCRIPTION:  
Same as photo #6

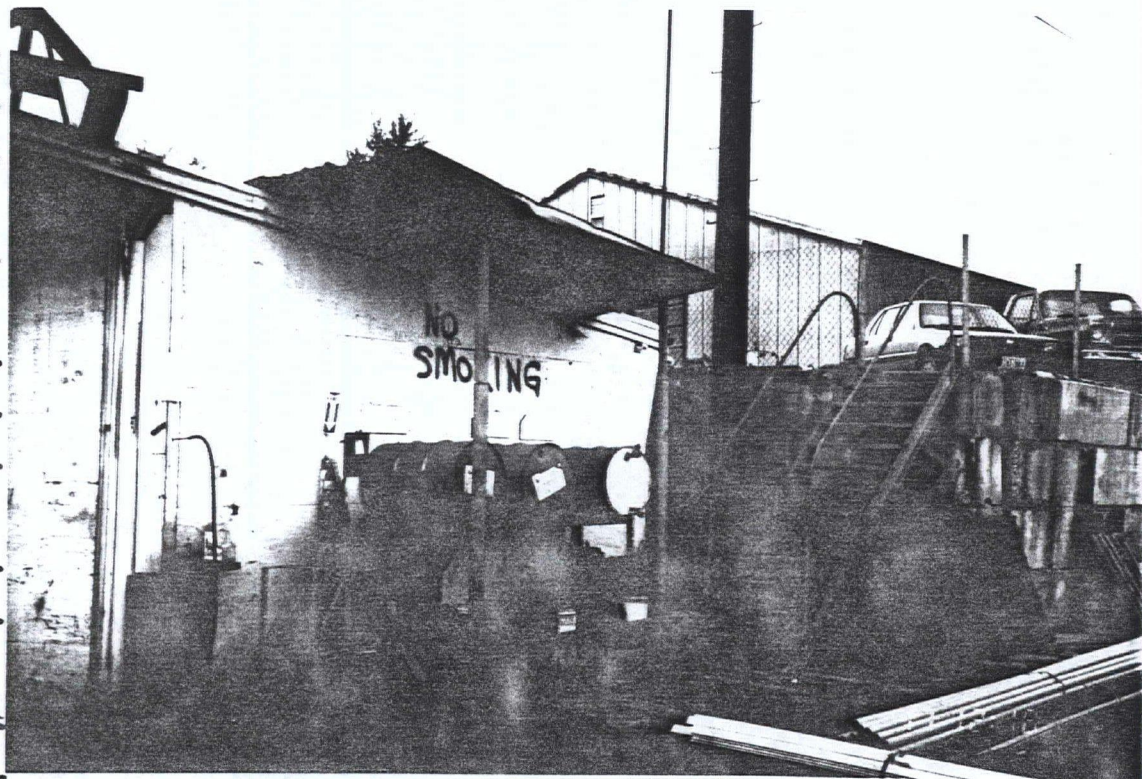
From the warehouse we looked at their maintenance shop. The shop contains small quantities of spray paints, brake fluid, and lubricants. Mr. Buckland explained that they need to fabricate replacement parts because the acids used in the processes eventually destroy equipment. Next to the shop three 55 gallon drums were stored within a covered bermed enclosure. The drums contain hydraulic oil, motor oil and solvent. Smaller buckets are used to capture any spills from the drums. A 55 gallon drum containing transmission fluid (see photo #8) was stored next to the bermed enclosure but outside the berm.

PHOTO NO.: 8  
DATE: 11/17/92  
TIME: 12:18  
TAKEN BY:  
J. Polaygs-Wier  
WITNESS:  
M. Turvey  
FILM: KODAK 200  
CAMERA: 35 mm  
LOCATION:  
Ace Galvanizing  
Seattle, WA.  
DESCRIPTION:  
Drums of hydraulic  
transmission fluid  
oil, motor oil &  
solvent stored outside under cover with berm. One drum outside  
of bermed area, contains transmission fluid.

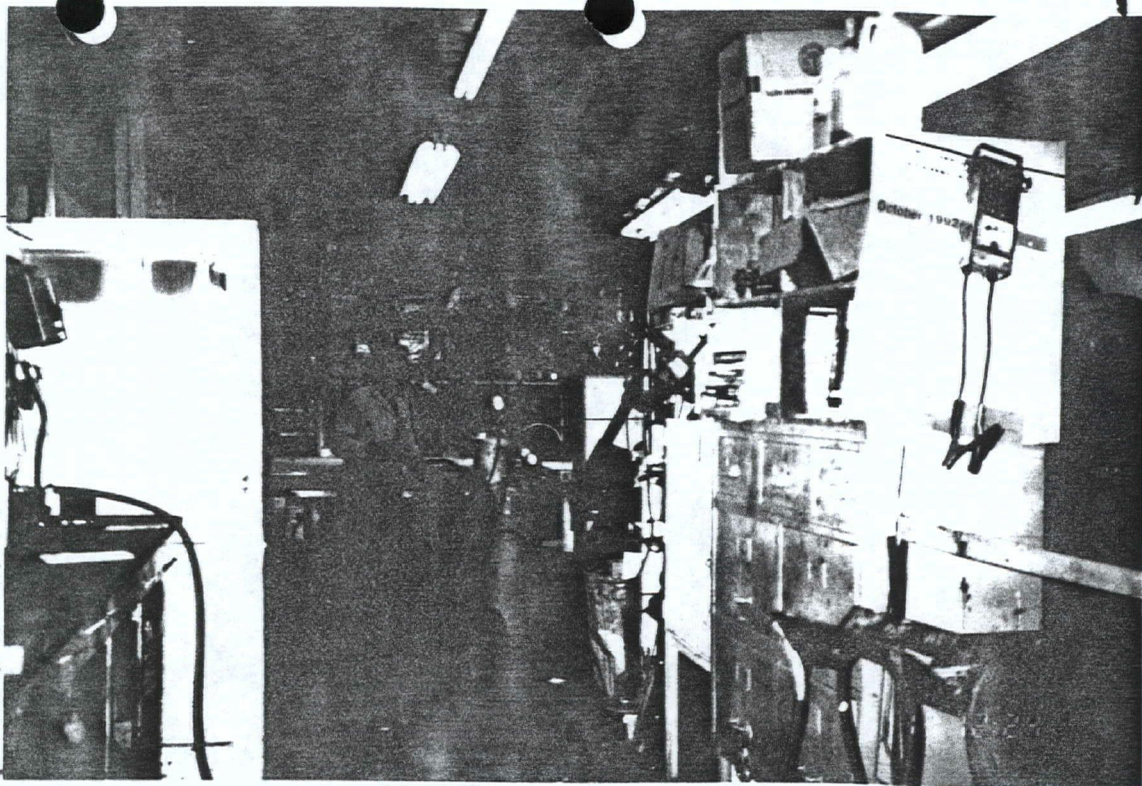
PHOTO NO.: 9  
DATE: 11/17/92  
TIME: 12:24  
TAKEN BY: J. Polyes-Wien  
WITNESS: M. Turvey  
FILM: KODAK 200  
CAMERA: 35mm  
LOCATION: Ace galvanizing  
Seattle, WA  
DESCRIPTION: Inside maintenance  
shop - no drums

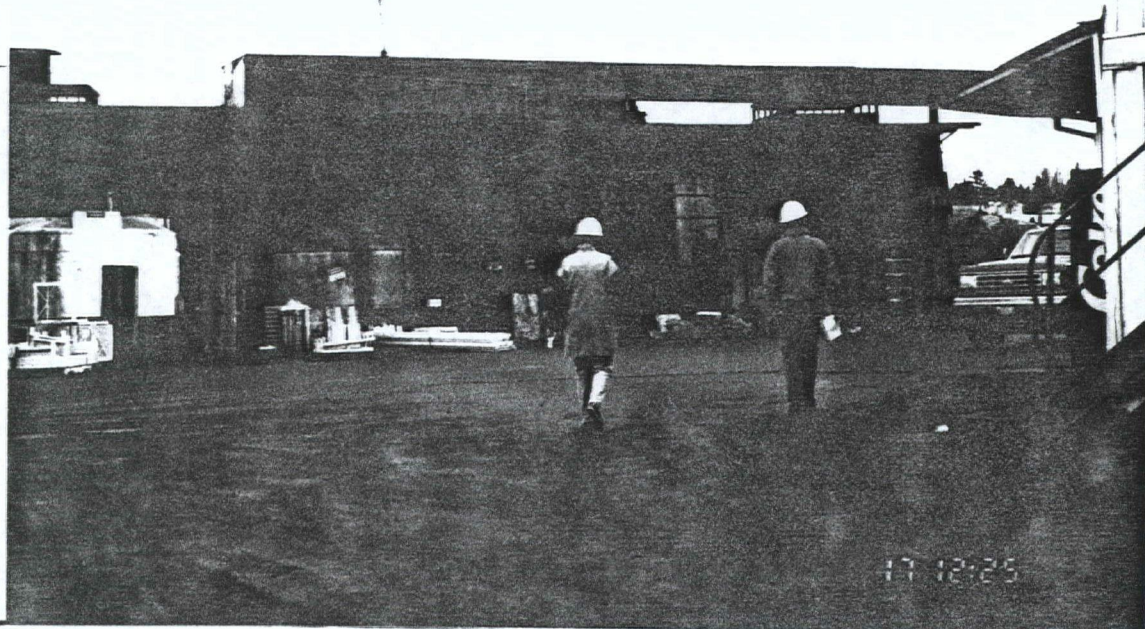
PHOTO NO.: 11

The dross was located next to several large tanks which is part of the recirculation system described above (see photos #11 and 13). Also stored outside of the bermed enclosure, near the dross were 2 batteries. Mr. Buckland directed one of his workman to remove the batteries and store them inside. The facility stores five 55 gallon drums of diesel within the bermed enclosure holding the tanks.

Looking at main  
building where  
galvanizing is done.  
Tanks used to  
recirculate acids & water back into process. Centrifuge removes  
metal crystals.

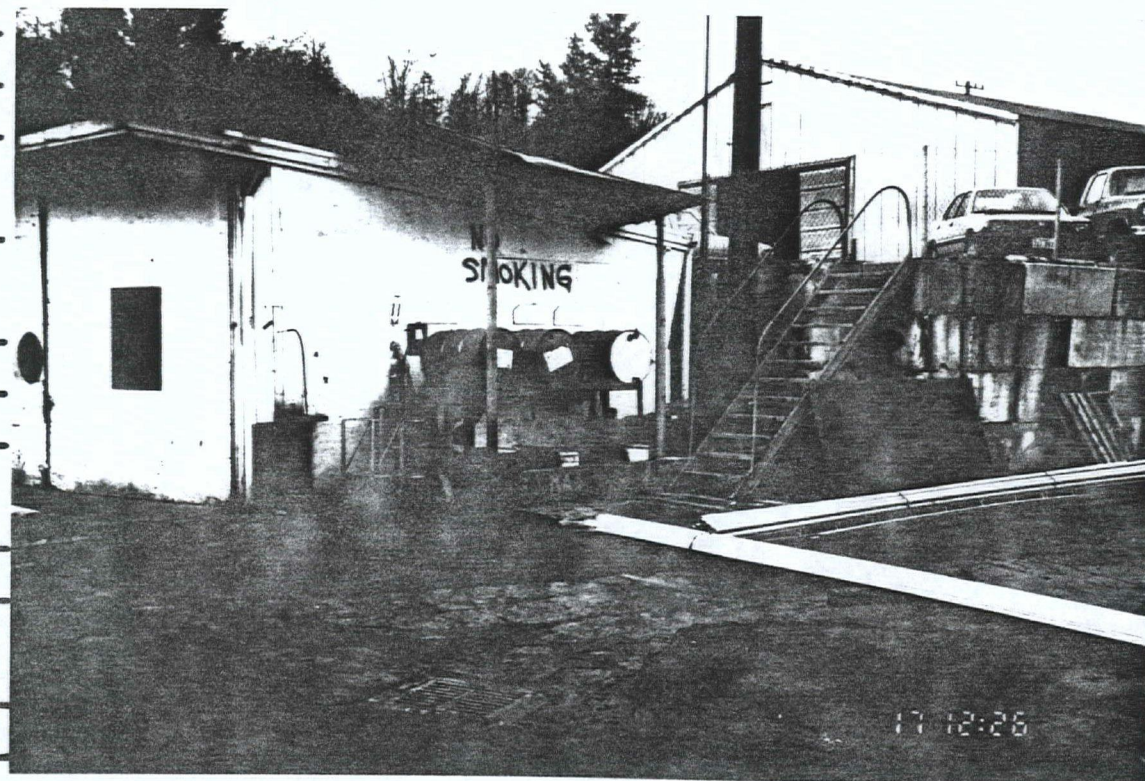
PHOTO NO.: 12

Same as photo #8  
but shows proximity  
of drum storage  
to storm drain.

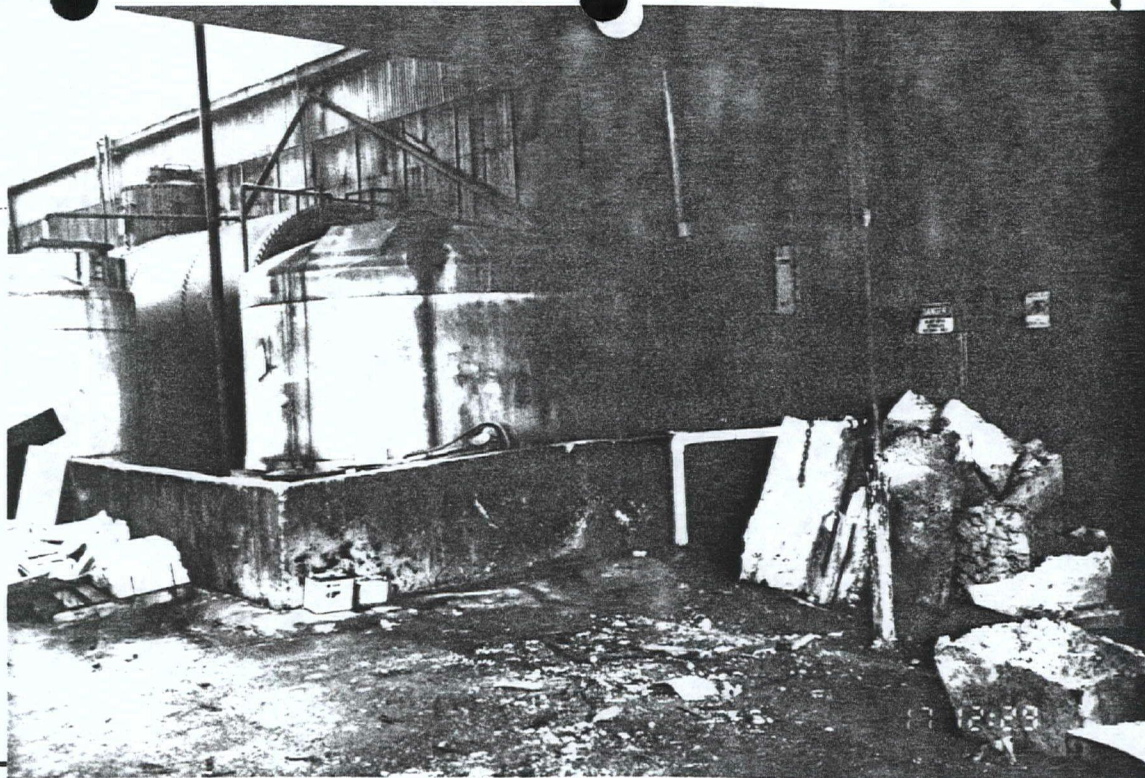
PHOTO NO.: 13

Mr. Buckland said that they generate an iron mash from their process which is shipped to Arlington. They use a centrifuge to separate metal crystals from the acids. This separation produces a dross which is sold to mining operations and to fertilizer companies. There were chunks of dross stored in the yard outside on the pavement. Mr. Buckland said that the dross would be picked up soon.

Chunks of iron &  
zinc dross &

Recirculating tank.

Two batteries on  
ground next to berm enclosure.

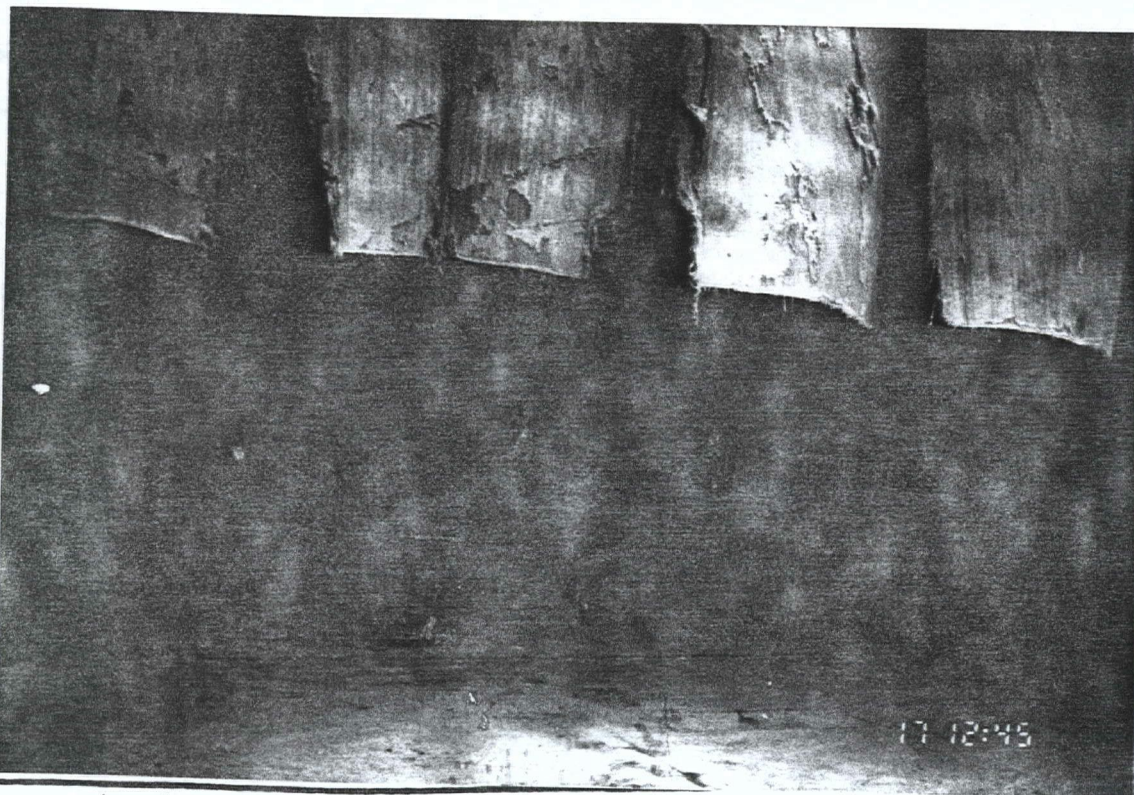
PHOTO NO.: 16

Inside look at  
galvanizing  
operation. Shields  
on left used to prevent back splash  
on workers.

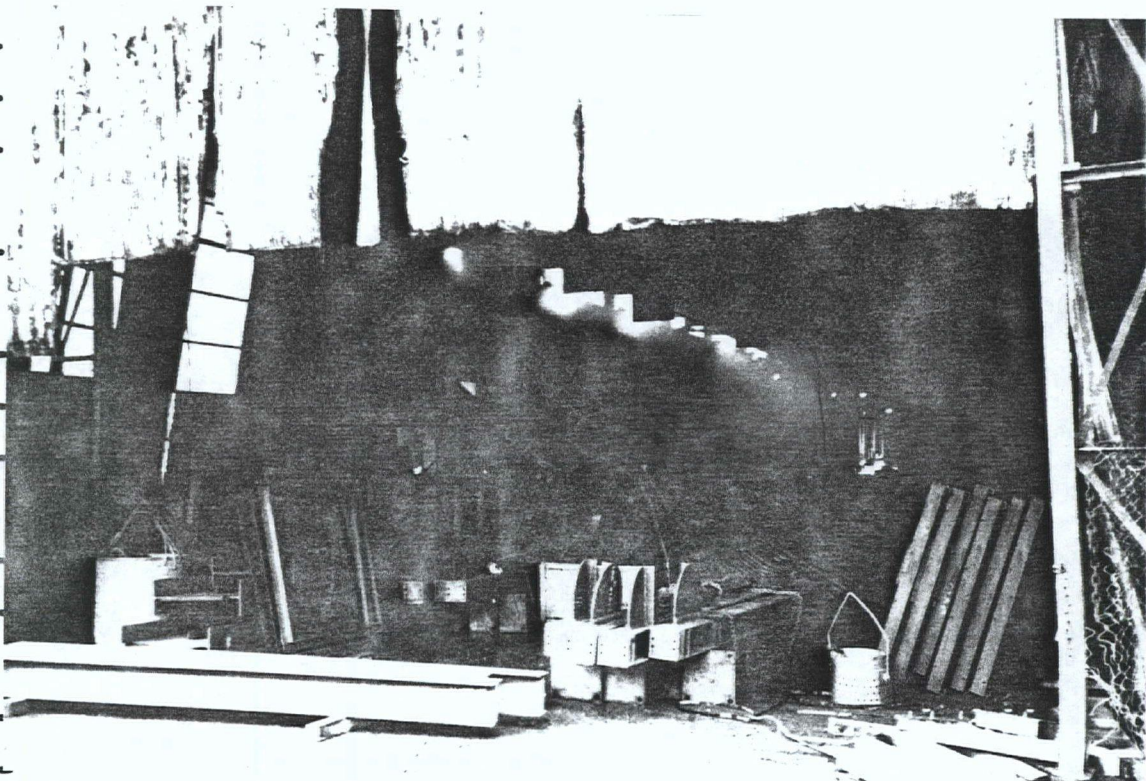
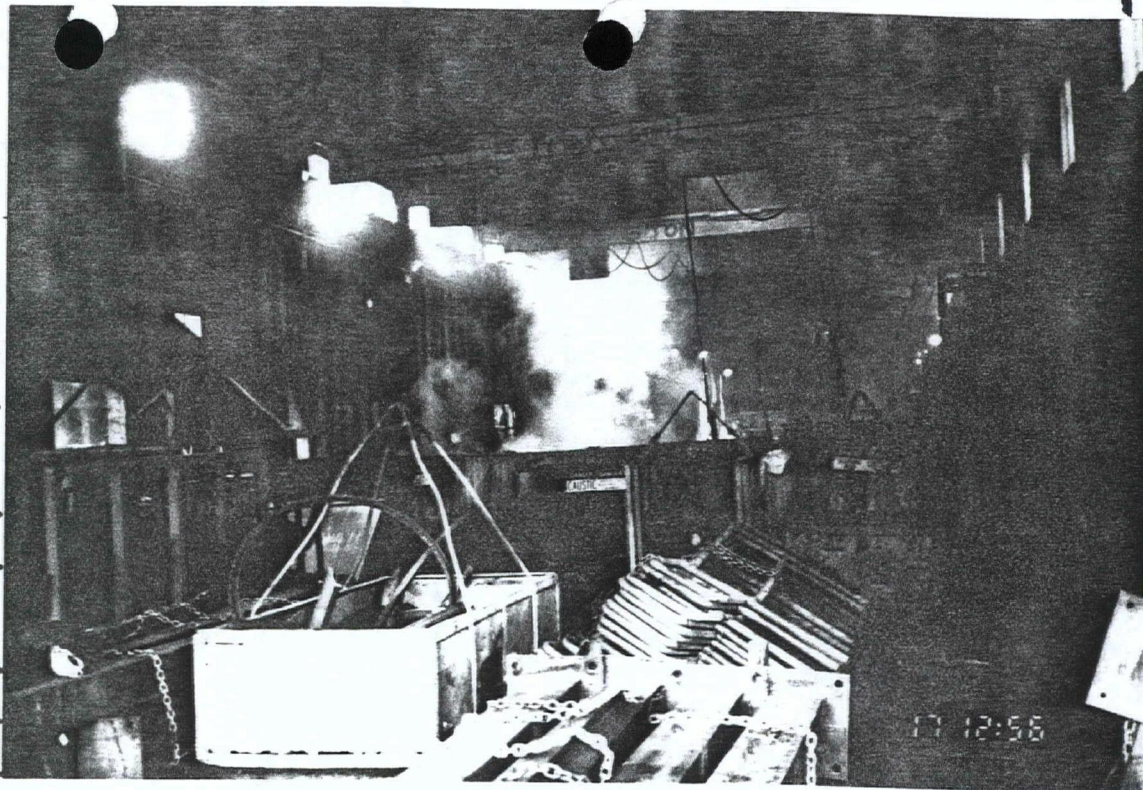
PHOTO NO.: 18

We walked to the entry area for the main building shown in photos 18, 19 and 20 and declined an opportunity to look at the inside galvanizing process because of the very strong fumes. Fumes are vented to the roof and released to the atmosphere. I mentioned to Mr. Buckland that we have received complaints concerning the fumes from neighboring

Inside main  
building. Fumes  
from acid tanks  
is vented thru roof.

DATE: 11/17/92  
TIME:             
TAKEN BY: J. Polansky-Wien  
WITNESS: M. Turvey  
FILM: KODAK 200  
CAMERA: 35 mm  
LOCATION: Ace Galvanizing  
Seattle, WA.  
DESCRIPTION: Same as photo #18

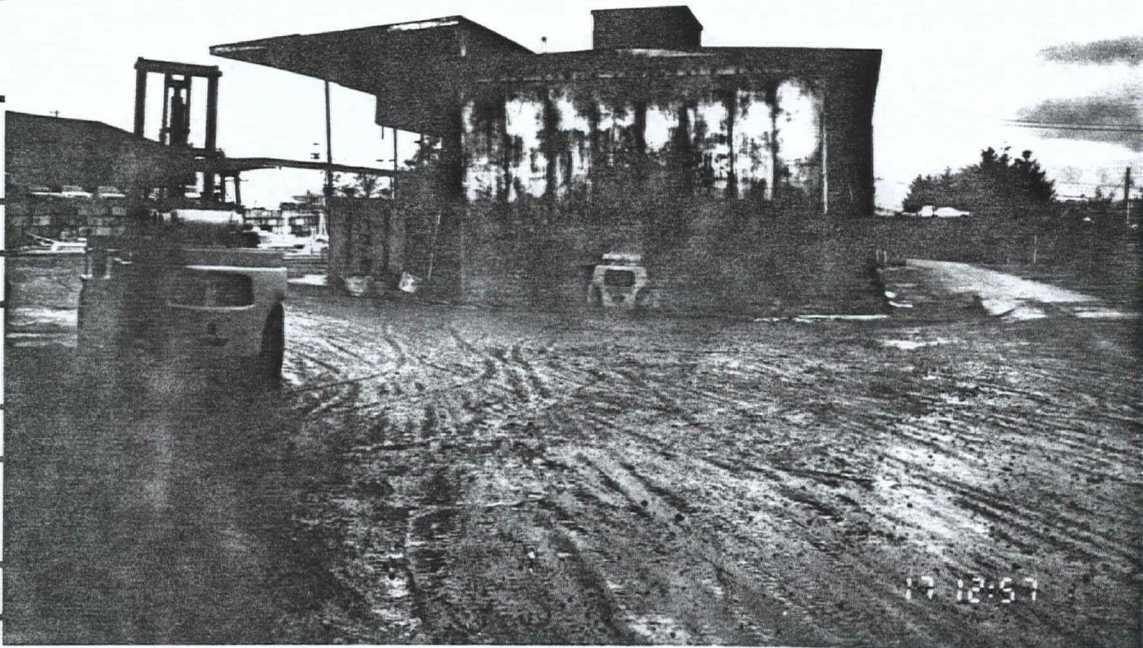
DESCRIPTION: Back end of  
main building  
where galvanizing  
is done. yard is muddy from yard  
traffic

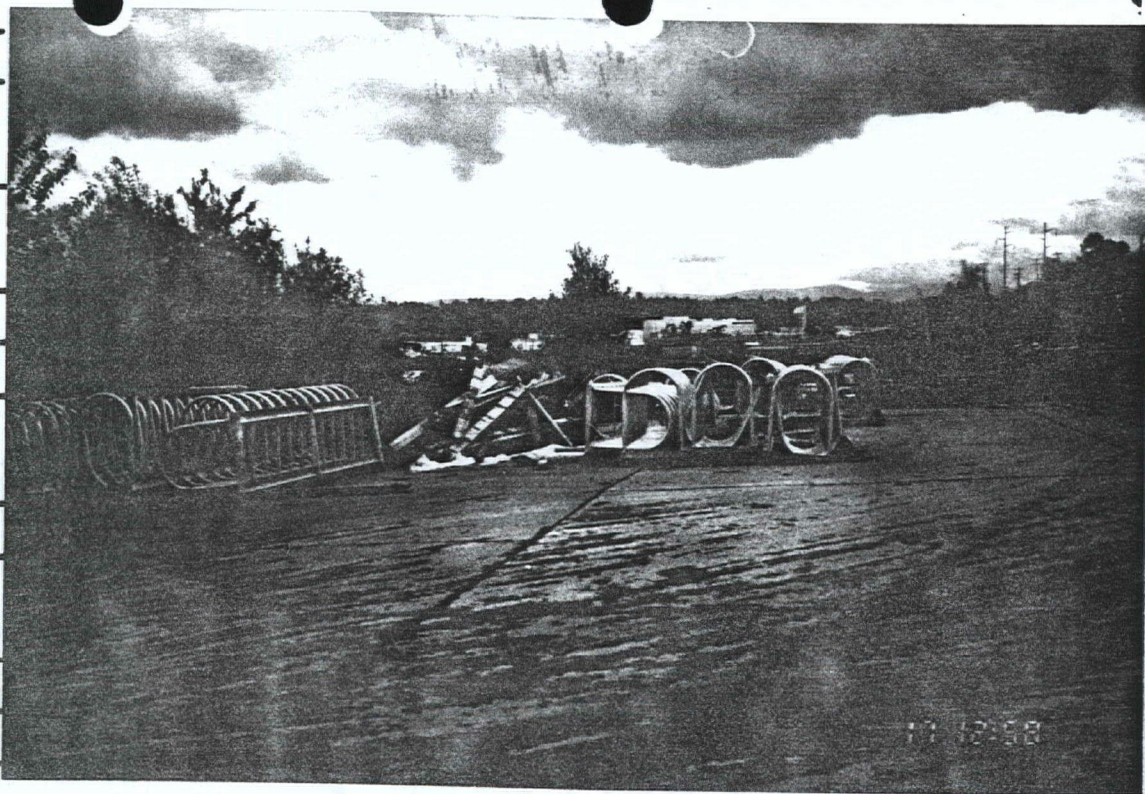
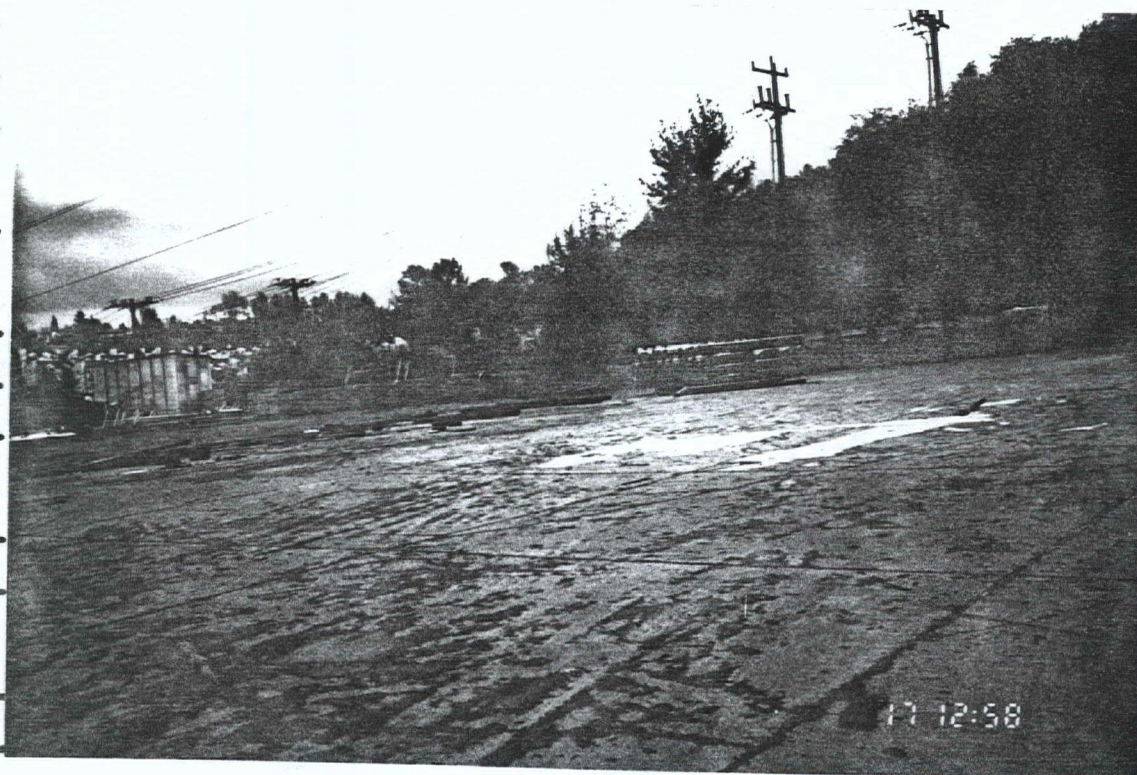
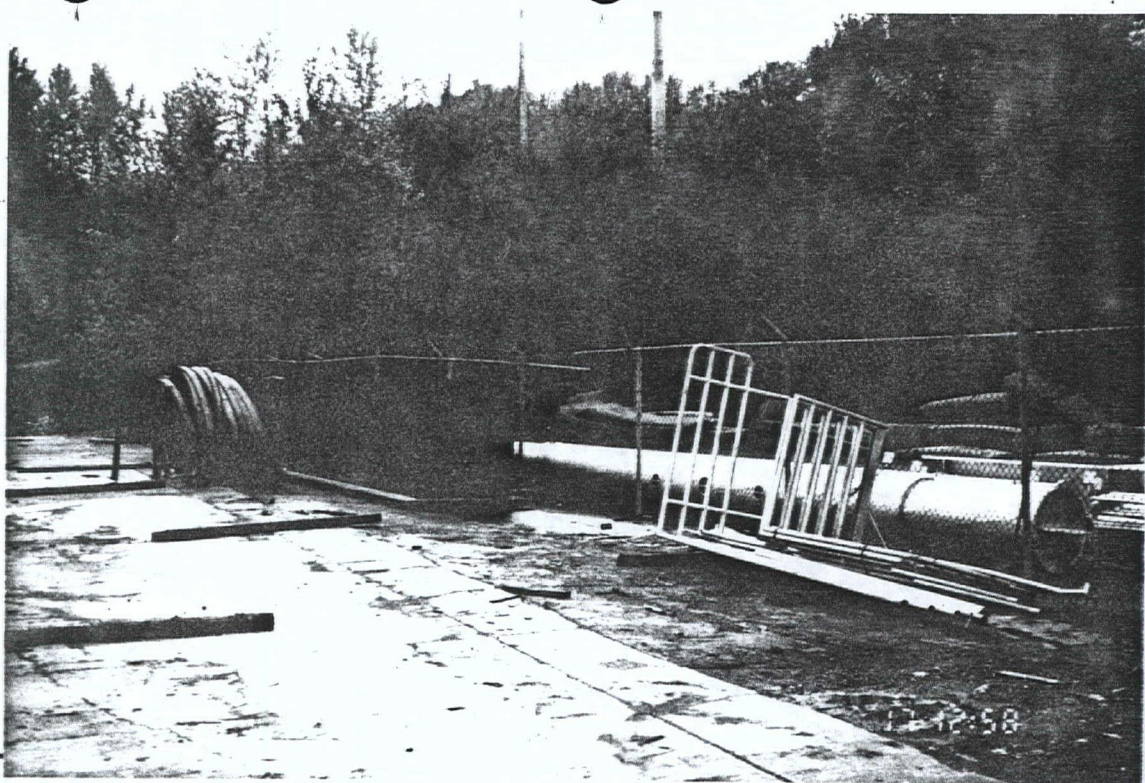
From here we looked at their storage yard. Mr. Buckland said they have plans to blacktop the entire yard. He said this would help keep the gravel out of the storm sewer. The yard is used to store parts (see photos 21,22 and 23). They had leased part of their yard to a company which built a satellite dish and building to house computers. The company removed the dish but abandoned the building. Mr. Buckland had no immediate plans to do anything with this part of the property.

Backyard storage  
of parts

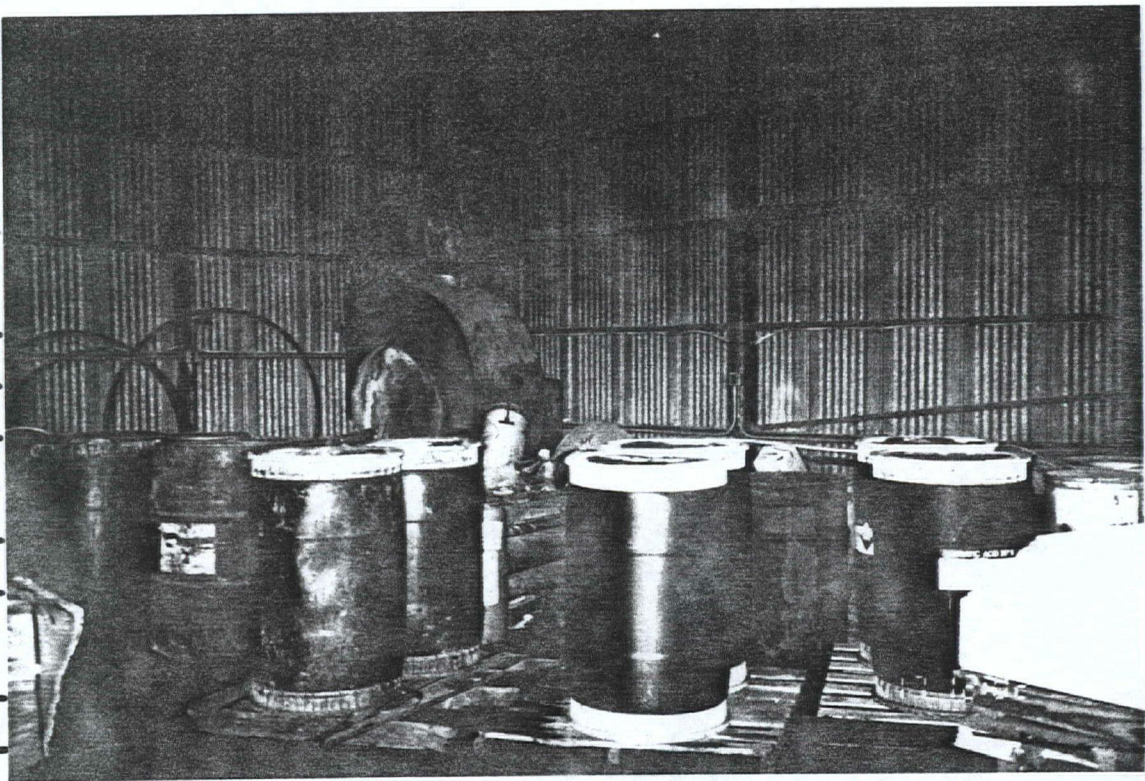
PHOTO NO.: 24

Inside warehouse -  
drum storage.
